# SECOND FIVE-YEAR REVIEW REPORT

## Bally Ground Water Contamination Superfund Site

Borough of Bally

Berks County, Pennsylvania

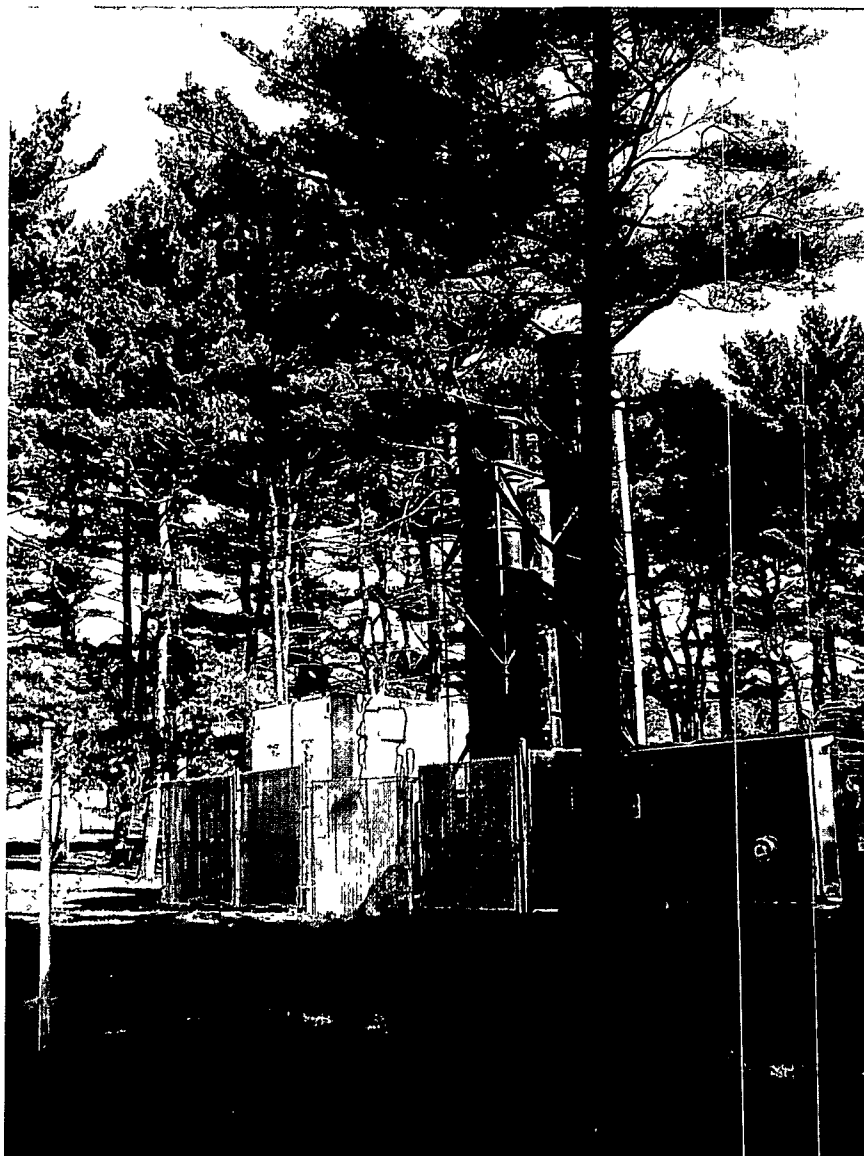
Photograph of the air-stripper treatment system present at Bally Municipal Well Number Three.

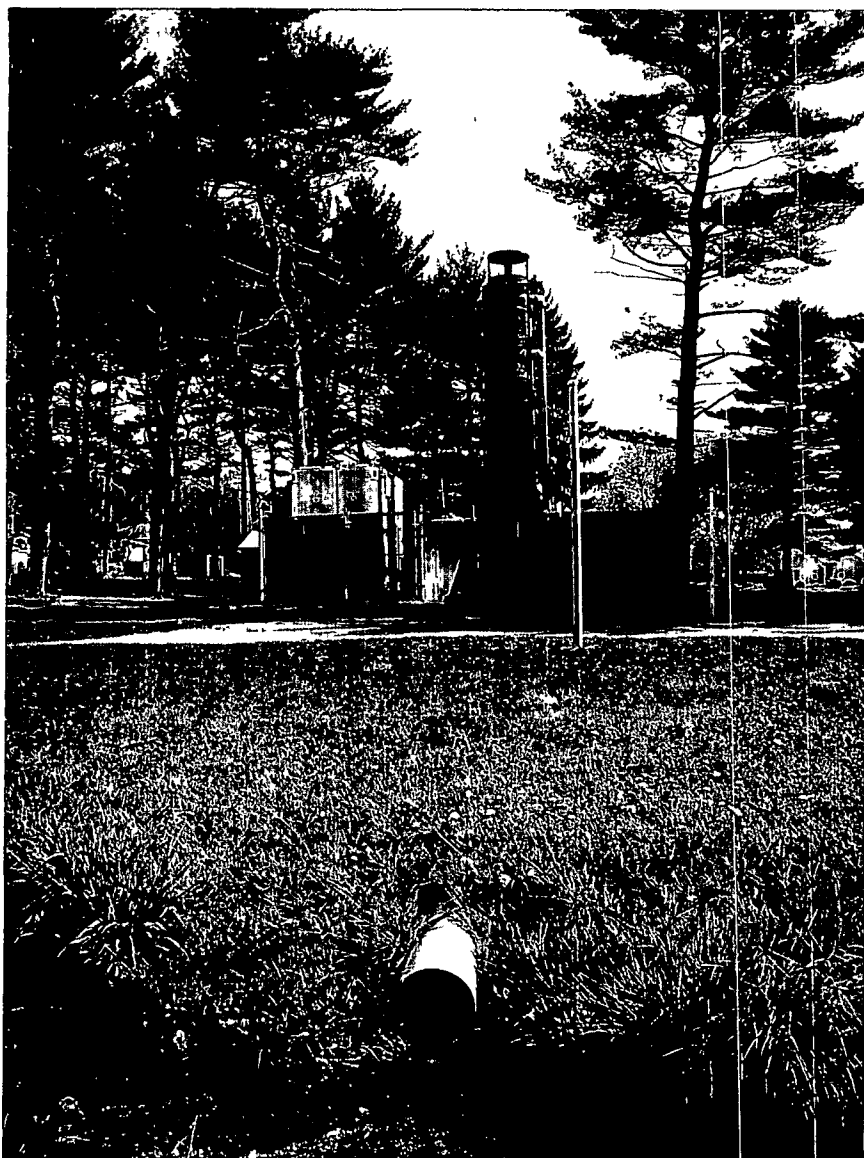
Photograph of the air-stripper treatment system outfall into an unnamed tributary of the West Branch of the Perkiomen Creek.
